HOME ANALYSIS SERVICE

Order Information			
This Report is Exclusively for:			
Client	Westmont Development	Inspection Date	12/22/10
Inspection Address	1105 Lincoln Ave., San Jose		
Weather Condition	Rain / Time 10:00 a.m.		
Agent	Chris Hopkins	Office	Westmont Dev.
Phone	(650) 996-2021	Fax

HOME ANALYSIS SERVICE
Residential & Commercial Property Inspections

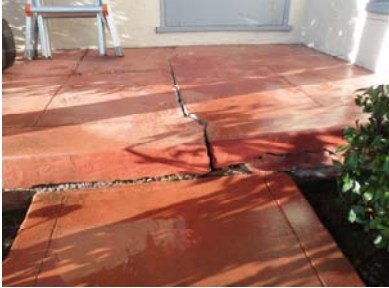
front porch settlement crack damage

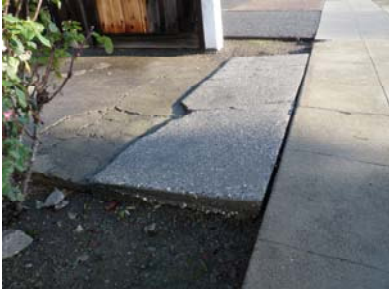
Driveway settlement and trip hazard side walk transition

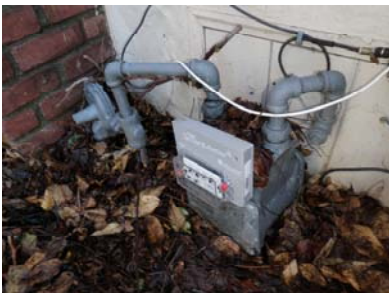
Gas meter and shutoff valve buried and not accessible

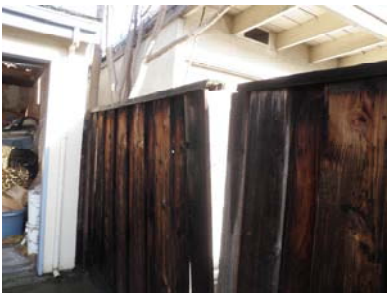
right side yard fence damage

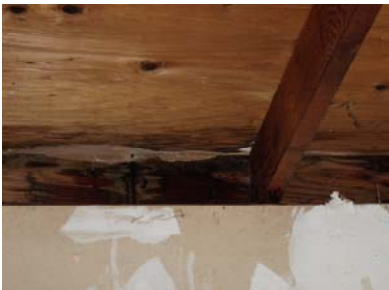
Detached garage roof structure fungus damage

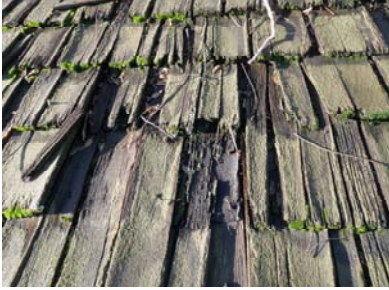
Deteriorated condition of roof wood shake coverage

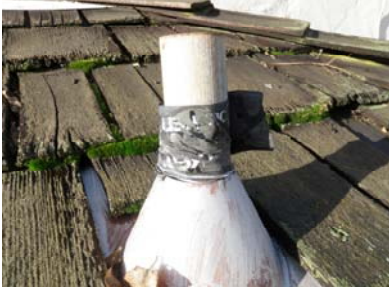
All vent jacks poorly sealed

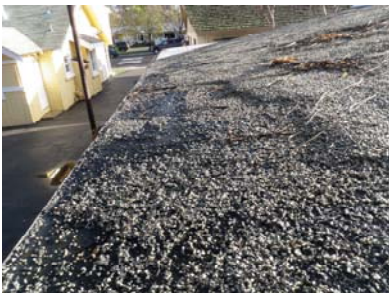
Detached garage deteriorated and blistered tar & gravel coverage

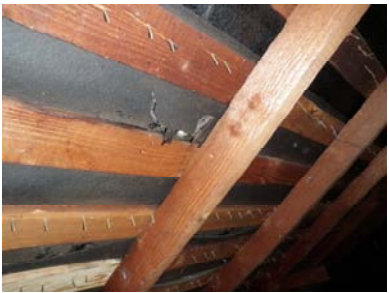
Roof felt underlayment penetration damages

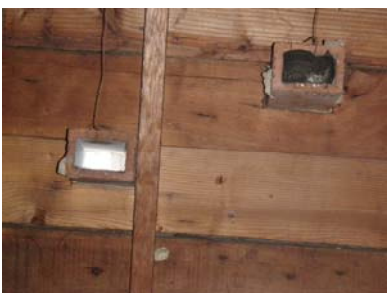
Gable vent tubes missing screen coverage

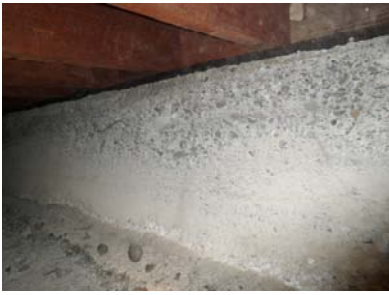
Poured concrete foundation surface spalling deterioration

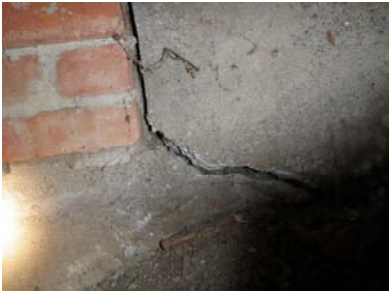
Chimney settlement attributing to foundation 1" displacement crack

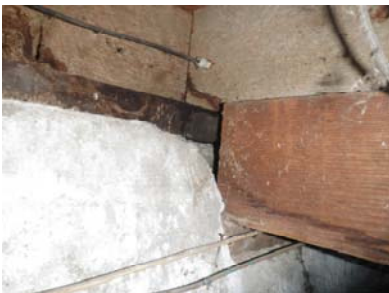
Sub structure support girder barely supported in pocket

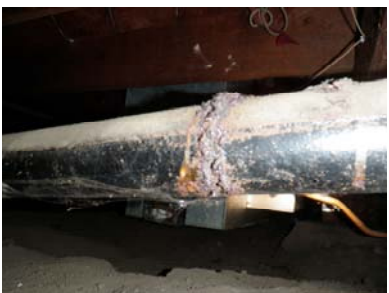
2" Cast iron drain pipe corrosion deterioration and leaking

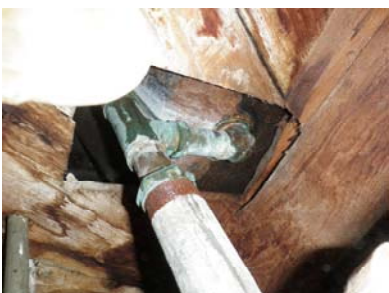
Bathtub hot / cold fixtures leaking in crawlspace during use
