WOOD DESTROYING PESTS AND ORGANISMS INSPECTION REPORT

BUILDING NO. 408	STREET, CITY, STATE, ZIP Fuller Avenue & 410, San Jose CA 95125	Date of Inspection 1/3/2011	No. of Pages 7
----------------------------	---	---------------------------------------	--------------------------

J & M TERMITE CONTROL, INC.

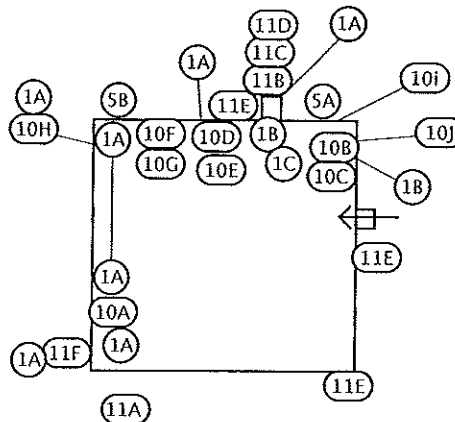
FRONT

COMPLETE REPORT <input checked="" type="checkbox"/>	LIMITED REPORT <input type="checkbox"/>	SUPPLEMENTAL REPORT <input type="checkbox"/>	REINSPECTION REPORT <input type="checkbox"/>
General Description: Two story duplex - wood, stucco exterior - tar and gravel roof.		Inspection Tag Posted: Water heater closet	
		Other Tags Posted: None reportable	
An inspection has been made to the structure(s) shown on the diagram in accordance with the Structural Pest Control Act. Detached porches, detached steps, detached decks and any other structures not on the diagram were not inspected.			
Subterranean Termites <input checked="" type="checkbox"/> Drywood Termites <input checked="" type="checkbox"/> Fungus/Dryrot <input checked="" type="checkbox"/> Other Findings <input checked="" type="checkbox"/> Further Inspection <input checked="" type="checkbox"/>			
If any of above boxes are checked, it indicates that there were visible problems in accessible areas. Read the report for details on checked items.
